SUBJECT: 2017 Annual (Operations and Maintenance) Compliance Inspection for East Jefferson Levee District – New Orleans East Bank (EJL1)

Flood Damage Reduction Segment / System Inspection Report

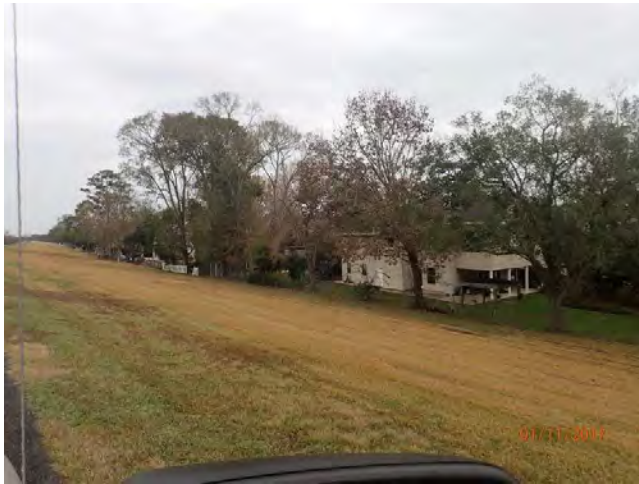
Inspect ID: USACE_CEMVN_EJL1_2017_a_0003
Title: USACE_CEMVN_EJL1_2017_a_0003_1.jpg
Rated Item: 01. Unwanted Vegetation Growth
Rating: M
Inspection Remarks: Trees marked for removal.
Recommended Action: USACE has an active contract to remove all vegetation in accordance with ETL 1110-2-583.
Caption:
Station 1: 224+66 (EJLD)
Station 2: 301+96 (EJLD)

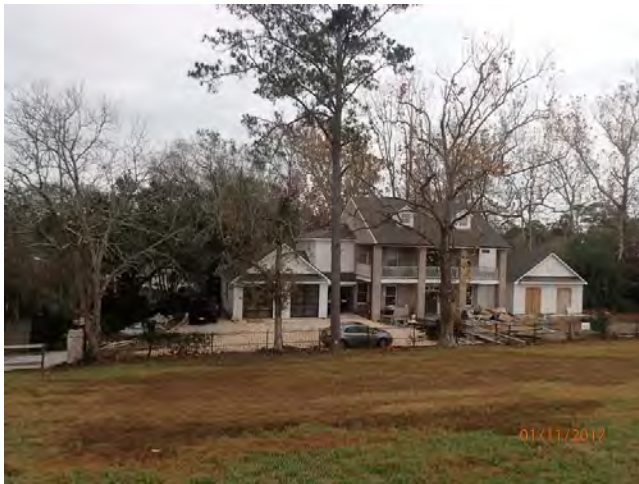
Inspect ID: USACE_CEMVN_EJL1_2017_a_0004
Title: USACE_CEMVN_EJL1_2017_a_0004_1.jpg
Rated Item: 01. Unwanted Vegetation Growth
Rating: M
Inspection Remarks: Trees to be removed from levee toe.
Recommended Action: USACE has an active contract to remove all vegetation in accordance with ETL 1110-2-583.
Caption:
Station 1: 292+98 (EJLD)

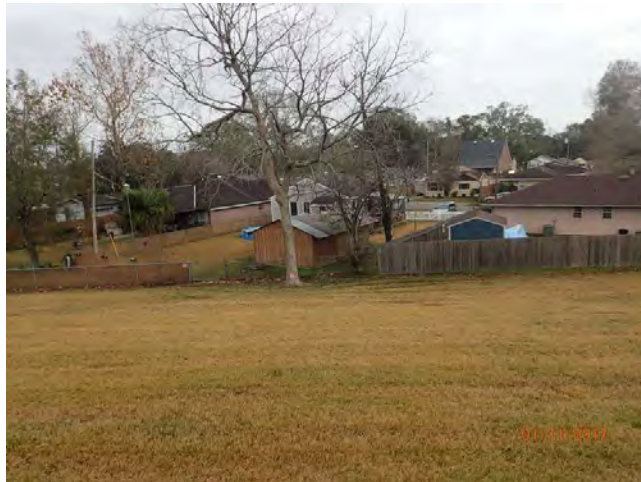
Inspect ID: USACE_CEMVN_EJL1_2017_a_0005

Station 1: 283+78 (EJLD)

Recommended Action: USACE has an active contract to remove all vegetation in accordance with ETL 1110-2-583.

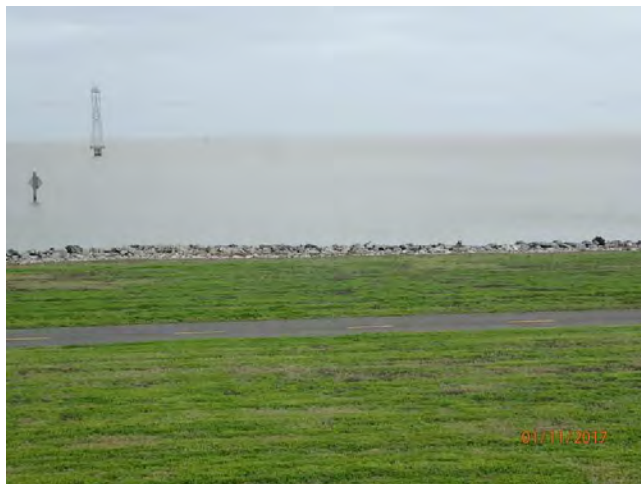
Inspect ID: USACE_CEMVN_EJL1_2017_a_0010

12. Riprap Revetments & Bank Protection	M	A No riprap displacement or stone degradation that could pose an immediate threat to the integrity of channel bank. Riprap intact with no woody vegetation present.	USACE_CEMVN_EJL1_2017_a_0010: Station_1 727+23: Foreshore riprap settling. Due to wave action the embankment adjacent to the rock dike has eroded approximately 150 feet long and 10 to 15 feet wide at approximate Station 726+50 to 728+00. In addition, the rock dike appears to have settled 1 to 2 feet. EJLD shall place additional embankment material to match the adjacent elevation that has not eroded. Seed, mulch and fertilize the repair area. EJLD shall visually monitor for future settlement. EJLD has an approved erosion repair plan and is currently implementing it. (M)
		M Minor riprap displacement or stone degradation that could pose an immediate threat to the integrity of the channel bank. Unwanted vegetation must be cleared or sprayed with an appropriate herbicide.

Recommended Action: EJLD shall place additional embankment material to match the adjacent elevation that has not eroded. Seed, mulch and fertilize the repair area. EJLD shall visually monitor for future settlement. EJLD has an approved erosion repair plan and is currently implementing it.

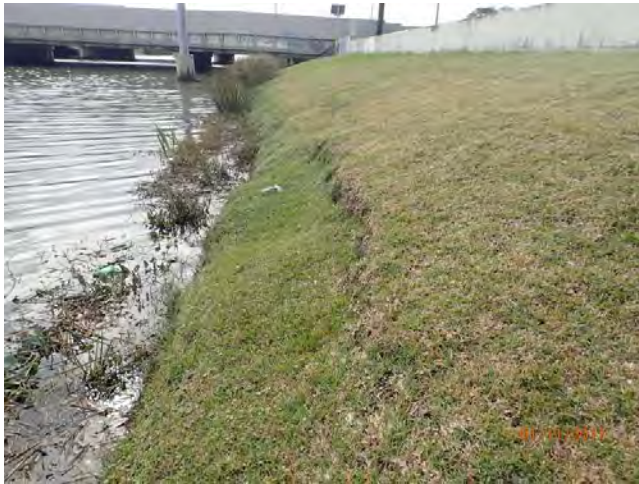
Inspect ID: USACE_CEMVN_EJL1_2017_a_0011

Rated Item: 06. Foundation of Concrete Structures

Station 1: 636+73 (17W)

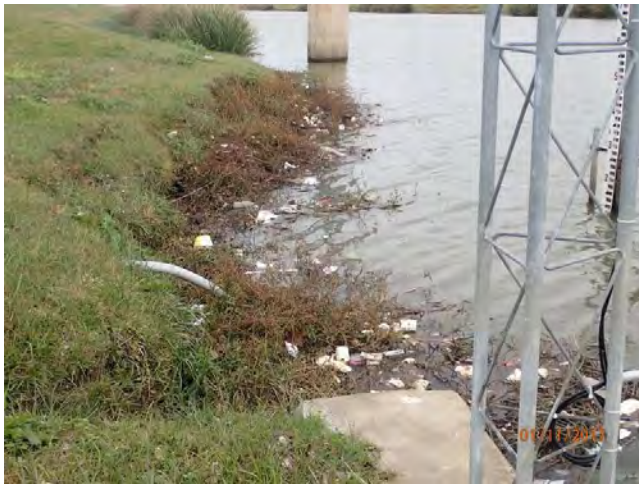
Inspect ID: USACE_CEMVN_EJL1_2017_a_0013

Rated Item: 06. Foundation of Concrete Structures
