SUBJECT: 2017 Annual (Operations and Maintenance) Compliance Inspection for Lake Borgne Basin Levee District – New Orleans East Bank (LBL1)

Flood Damage Reduction Segment / System Inspection Report

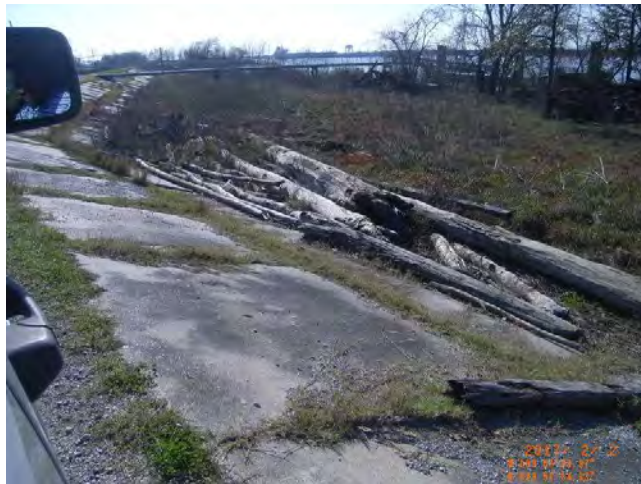
Inspect ID: USACE_CEMVN_LBL1_2017_a_0030

Recommended Action: SLFPA-E is responsible for clearing all obstructions from within the levee ROW.

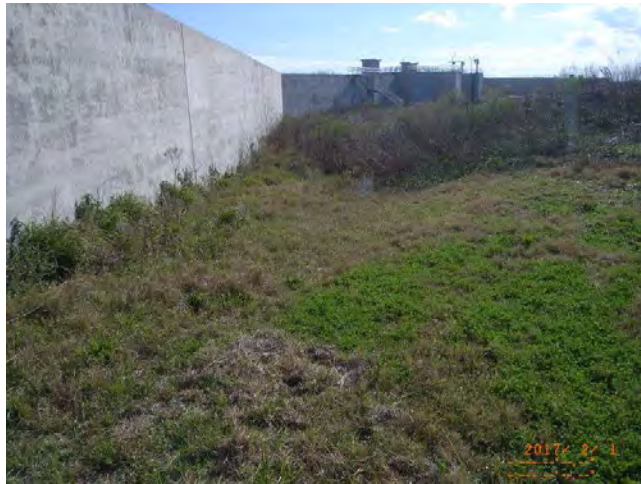
Caption:
Station 1: 702+35 (CLP)

Inspect ID: USACE_CEMVN_LBL1_2017_a_0004
Title: USACE_CEMVN_LBL1_2017_a_0004_1.jpg
Rated Item: 12. Riprap Revetments & Bank Protection
Rating: M

Inspection Remarks: Unwanted vegetation in riprap on landside at Bayou Dupre Structure.
Recommended Action: SLFPA-E should remove unwanted vegetation from vegetation-free zone, up to the levee ROW (ETL 1110-2-583).

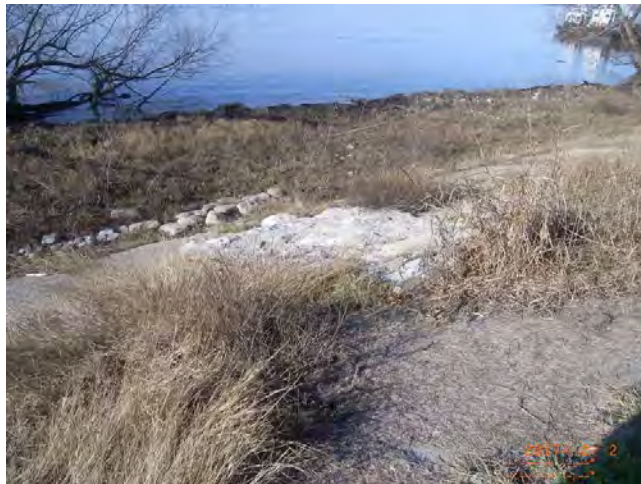
Inspect ID: USACE_CEMVN_LBL1_2017_a_0022
Title: USACE_CEMVN_LBL1_2017_a_0022_1.jpg
Rated Item: 13. Revetments other than Riprap
Rating: M

Inspection Remarks: Lack of scour protection on landside slope pavement.
Recommended Action: SLFPA-E will provide permanent repairs.

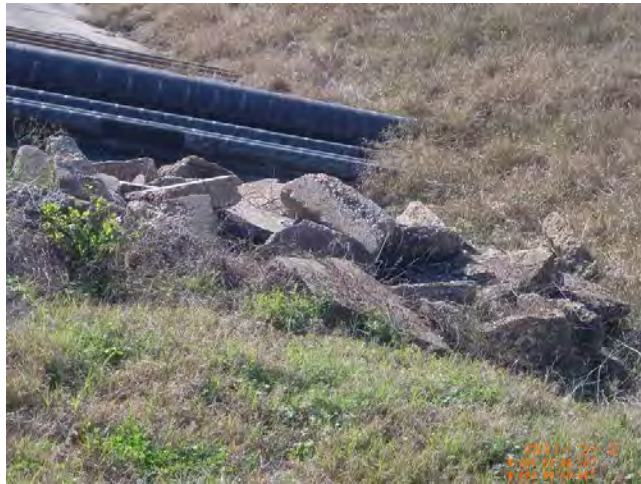
Inspect ID: USACE_CEMVN_LBL1_2017_a_0045
Title: USACE_CEMVN_LBL1_2017_a_0045_1.jpg
Rated Item: 13. Revetments other than Riprap
Rating: M
Inspection Remarks: Broken riprap on floodside slope pavement.
Recommended Action: SLFPA-E will provide permanent repairs.
Caption:
Station 1: 192+40 (LBLD)

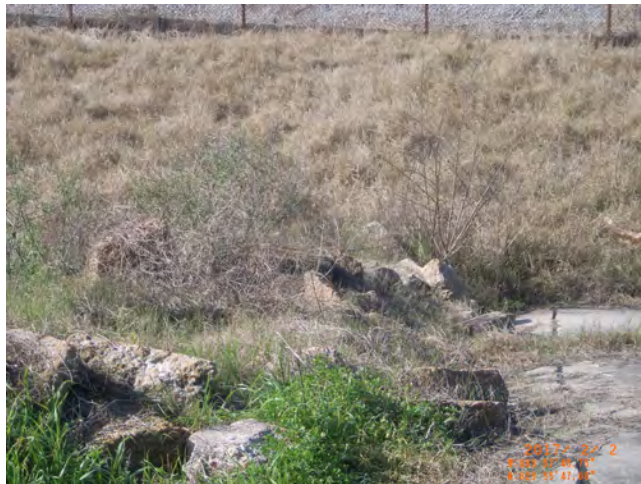
Inspect ID: USACE_CEMVN_LBL1_2017_a_0046
Title: photo
Rated Item: 13. Revetments other than Riprap
Rating: M
Inspection Remarks: Temporary riprap on floodside slope pavement.
Recommended Action: SLFPA-E will provide permanent repair.
Caption:
Station 1: 196+21 (LBLD)
