US Army Corps of Engineers

Flood Damage Reduction Segment / System Inspection Report

Name of Segment / System : Orleans LD - New Orleans East Bank (Orleans Metro Subbasin) (OLD1)
 Public Sponsor(s): Southeast Louisiana Flood Protection Authority - East
 Public Sponsor Representative: Robert Turner - Regional Director
 Sponsor Phone: 504 262-8902
 Sponsor Email: rturner@slfpa.com
 Corps of Engineers Inspector: Kelly Danton, Carl Balint, David Duthu, Nicholas Ferina, Paul Wiltz, Raehael Maltzahn, Jabeen Pasha, Ben S Barcelona
 Inspection Report Prepared By: Nicholas Ferina, David Duthu
 Internal Technical Review (For Periodic Inspection): Prepared By: Mark Woodward, P.E.
 Final Approved By: Jean Vossen, P.E. *JV* Date of ITR: *13/17*
 Inspection Start Date: 03/16/2017
 Inspection End Date: 04/12/2017
 Date Report Prepared: 04/17/2017
 Date Approved: *10/4/17*

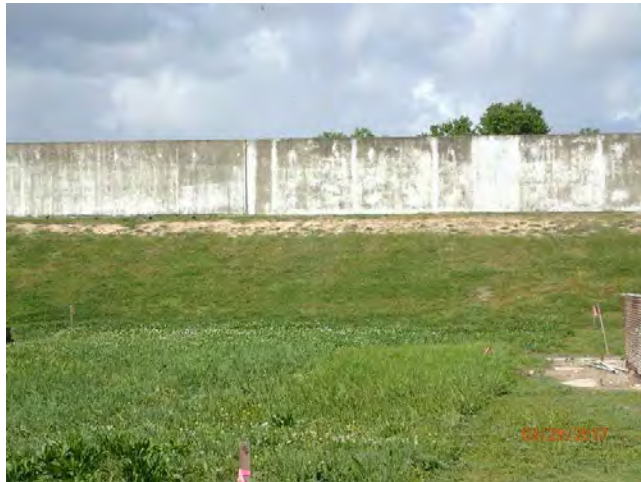
Inspect ID: USACE_CEMVN_OLD1_2017_a_0110

02. Sod Cover	M	A There is good coverage of sod over the levee.	USACE_CEMVN_OLD1_2017_a_0110: Station_1 116+19: Lack of sod cover along crown. SLFPA-E has plans to repair. SLFPA-E shall fertilize and seed areas until adequate sod cover is achieved. (M)
		M Approximately 25% of the sod cover is missing or damaged over a significant portion or over significant portions of the levee embankment. This may be the result of over-grazing or feeding on the levee, unauthorized vehicular traffic, chemical or insect problems, or burning during inappropriate seasons.	
		U Over 50% of the sod cover is missing or damaged over a significant portion or portions of the levee embankment.	
		N/A Surface protection is provided by other means.

Inspection Remarks: Lack of sod cover along crown. SLFPA-E has plans to repair.

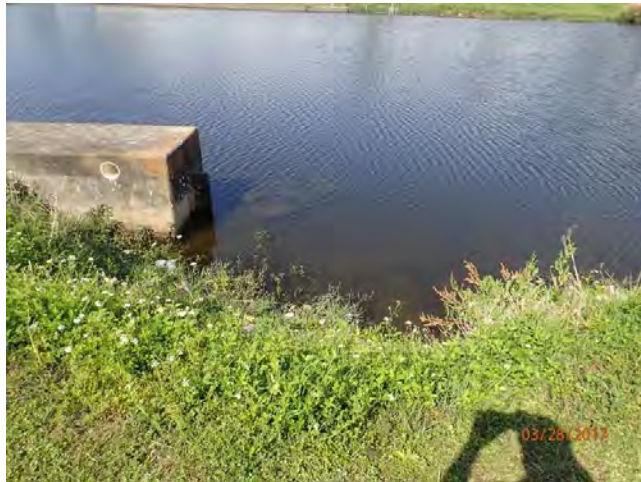
Inspect ID: USACE_CEMVN_OLD1_2017_a_0102

06. Erosion/ Bank Caving	M	A	USACE_CEMVN_OLD1_2017_a_0102: Station_1 669+93: Erosion around southeast end of the 17th Street Outfall Canal pump station wingwall. SLFPA-E should monitor the erosion and contact USACE if conditions worsen. (M)	
		M		There are areas where minor erosion is occurring or has occurred on or near the levee embankment, but levee integrity is not threatened.
		U		Erosion or caving is occurring or has occurred that threatens the stability and integrity of the levee. The erosion or caving has progressed into the levee section or into the extended footprint of the levee foundation and has compromised the levee foundation stability.

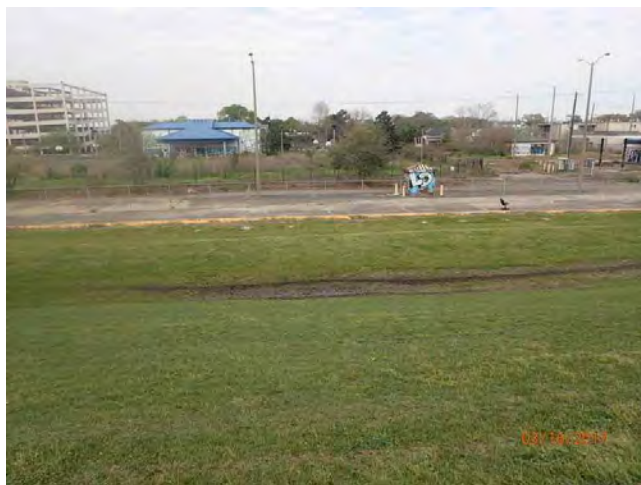
Inspect ID: USACE_CEMVN_OLD1_2017_a_0004

08. Depressions/ Rutting	M	A	USACE_CEMVN_OLD1_2017_a_0004: Station_1 601+45: Rutting on landside toe from vehicles. SLFPA-E shall repair depressed or rutted areas with compacted clay fill. The areas shall then be fertilized and seeded. (M) USACE_CEMVN_OLD1_2017_a_0005: Station_1 21+73: Ponding water near fire hydrant on floodside. SLFPA-E	
		M		There are some infrequent minor depressions less than 6 inches deep in the levee crown, embankment, or access roads that will pond water.
		U		There are depressions greater than 6 inches deep that will pond water.

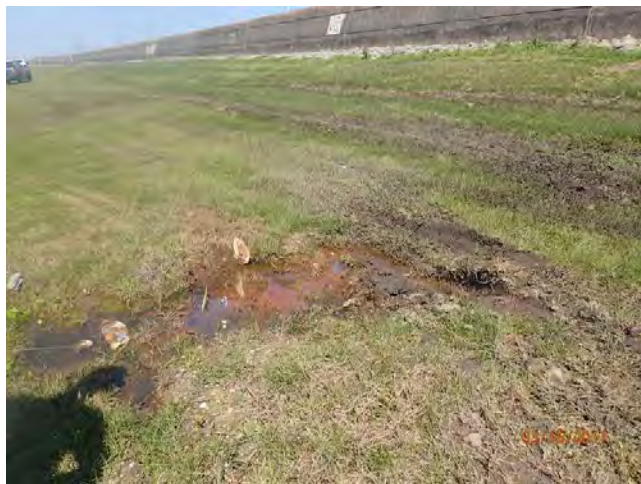
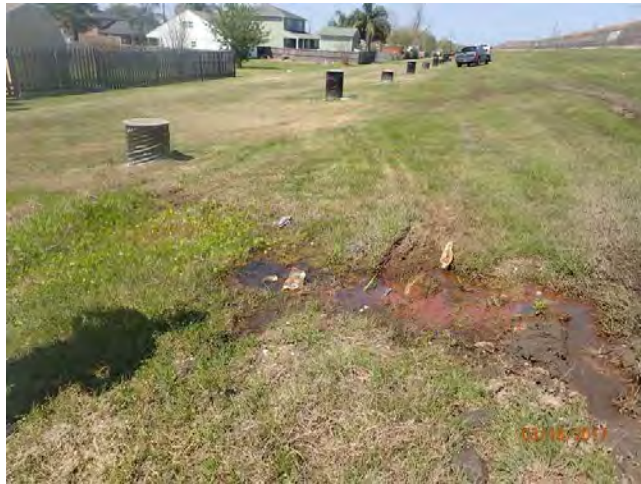
Inspect ID: USACE_CEMVN_OLD1_2017_a_0015

Rated Item	Rating	Rating Guidelines	Locations/Remarks/Recommendations
			<p>shall repair depressed or rutted areas with compacted clay fill. The areas shall then be fertilized and seeded. (M)</p> <p>USACE_CEMVN_OLD1_2017_a_0015: Station_1 253+37: Ruts with ponding water on landside of wall near relief well. SLFPA-E shall repair depressed or rutted areas with compacted clay fill. The areas shall then be fertilized and seeded. (M)</p> <p>USACE_CEMVN_OLD1_2017_a_0101: Station_1 587+14: Rutting and erosion on the landside levee slope below the floodwall. SLFPA-E shall repair depressed or rutted areas with compacted clay fill. The areas shall then be fertilized and seeded. SLFPA-E has a contract out for this to be repaired. (M)</p> <p>USACE_CEMVN_OLD1_2017_a_0105: Station_1 15+33: Depressions from mowers. SLFPA-E shall repair depressed or rutted areas with compacted clay fill. The areas shall then be fertilized and seeded. (M)</p> <p>USACE_CEMVN_OLD1_2017_a_0107: Station_1 47+47: Standing water on the landside toe. SLFPA-E shall ensure proper drainage. SLFPA-E shall repair depressed or rutted areas with compacted clay fill. The areas shall then be fertilized and seeded. (M)</p> <p>USACE_CEMVN_OLD1_2017_a_0108: Station_1 84+11: Ruts along the landside levee slope. SLFPA-E shall repair eroded areas with compacted clay fill. The areas shall then be fertilized and seeded. (M)</p>
