SUBJECT: 2017 Annual (Operations and Maintenance) Compliance Inspection for Orleans Levee District – New Orleans East Bank (Orleans East Subbasin) (OLD2)

Flood Damage Reduction Segment / System Inspection Report

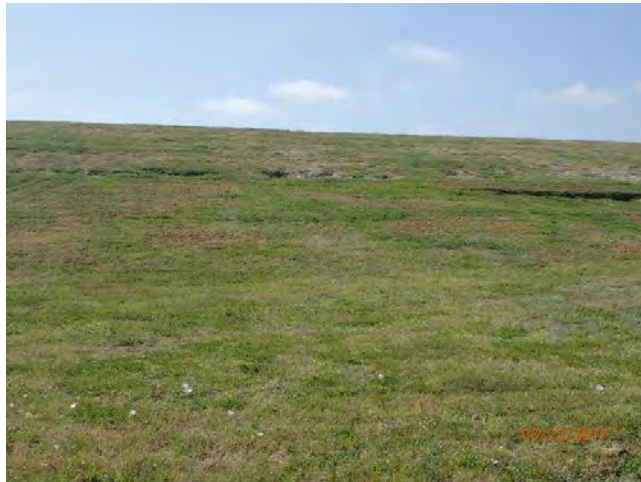
Inspect ID: USACE_CEMVN_OLD2_2017_a_0006

02. Sod Cover	M	A There is good coverage of sod over the levee.	USACE_CEMVN_OLD2_2017_a_0006: Station_1 336+05: Station_2 346+29: Poor sod cover on slope leading to some erosion. SFLPA-E shall fertilize and seed areas until adequate sod cover is achieved. (M) USACE_CEMVN_OLD2_2017_a_0012: Station_1 1063+27: Poor sod cover with shells washing out along slope. SFLPA-E should fertilize and seed areas until adequate sod cover is achieved. (M)
		M Approximately 25% of the sod cover is missing or damaged over a significant portion or over significant portions of the levee embankment. This may be the result of over-grazing or feeding on the levee, unauthorized vehicular traffic, chemical or insect problems, or burning during inappropriate seasons.	
		U Over 50% of the sod cover is missing or damaged over a significant portion or portions of the levee embankment.	
		N/A Surface protection is provided by other means.

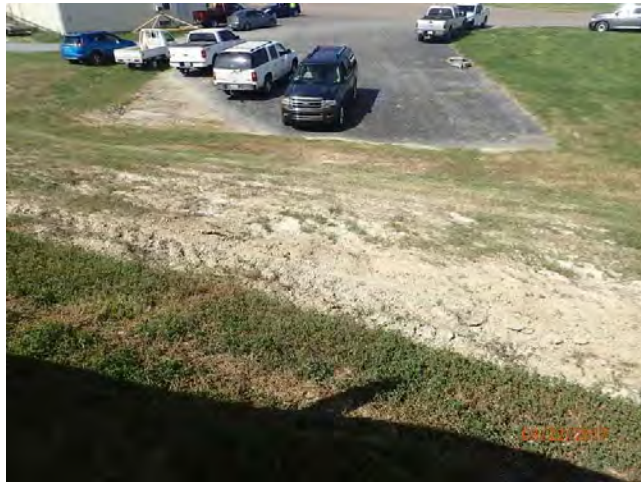
Inspect ID: USACE_CEMVN_OLD2_2017_a_0004
Title: USACE_CEMVN_OLD2_2017_a_0004_1.jpg
Rated Item: 06. Erosion/ Bank Caving
Rating: M
Inspection Remarks: Erosion on floodside slope
Recommended Action: SFLPA-E should monitor erosion.
Caption:
Station 1: 321+53 (NOECB)
Station 2: 324+47 (NOECB)

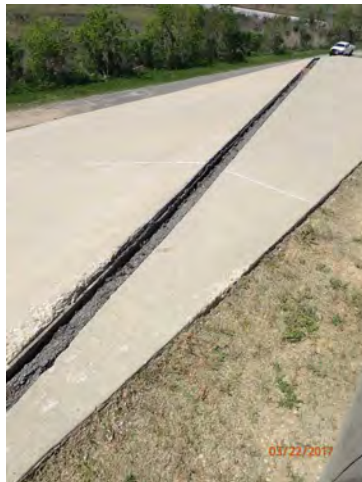
Inspect ID: USACE_CEMVN_OLD2_2017_a_0011
Title: USACE_CEMVN_OLD2_2017_a_0011_1.jpg
Rated Item: 13. Revetments other than Riprap
Rating: A
Inspection Remarks: Separation at transition.
Recommended Action: SFLPA-E has filled gap and they should continue to monitor and make repairs in accordance with Vol. 2 of OMRR&R manual.
Caption:
Station 1: 1065+19 (NOE)
