SUBJECT: 2017 Annual (Operations and Maintenance) Compliance Inspection for Orleans Levee District – New Orleans East Bank (St. Bernard Subbasin) (OLD3)

# Flood Damage Reduction Segment / System Inspection Report

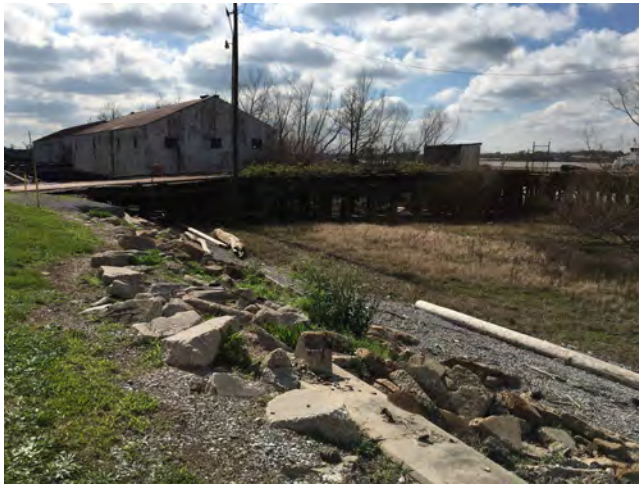
**Inspect ID:** USACE\_CEMVN\_OLD3\_2017\_a\_0005

**Station 1:** 685+86 (OLD)

**Recommended Action:** SLFPA-E should monitor the erosion and make corrective actions as required.

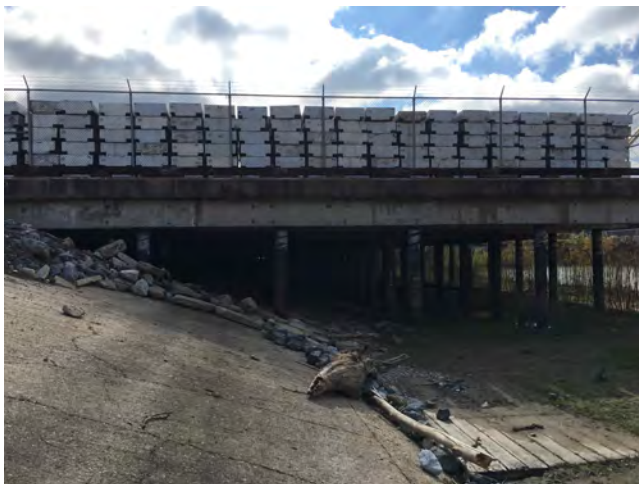
**Inspect ID:** USACE\_CEMVN\_OLD3\_2017\_a\_0006

13. Revetments other than Riprap	M	A Existing revetment protection is properly maintained, undamaged, and clearly visible.	USACE_CEMVN_OLD3_2017_a_0006: Station_1 667+39: The slope paving is crumbling at the head of the wharf. This location has rip rap and sandbags placed from previous flood events but has begun to erode again. Sandbags have deteriorated. SLFPA-E should coordinate with wharf owner to make repairs under wharf and add temporary repair (rocks or sandbags) as needed. (M)
		M Minor revetment displacement or deterioration that does not pose an immediate threat to the integrity of the levee. Unwanted vegetation must be cleared or sprayed with an appropriate herbicide.	
		U Significant revetment displacement, deterioration, or exposure of bedding observed. Scour activity is undercutting banks, eroding embankments, or impairing channel flows by causing turbulence or shoaling. Revetment protection is hidden by dense brush and trees.

**Inspection Remarks:** The slope paving is crumbling at the head of the wharf. This location has rip rap and sandbags placed from previous flood events but has begun to erode again. Sandbags have deteriorated.

**Recommended Action:** SLFPA-E should coordinate with wharf owner to make repairs under wharf and add temporary repair (rocks or sandbags) as needed.

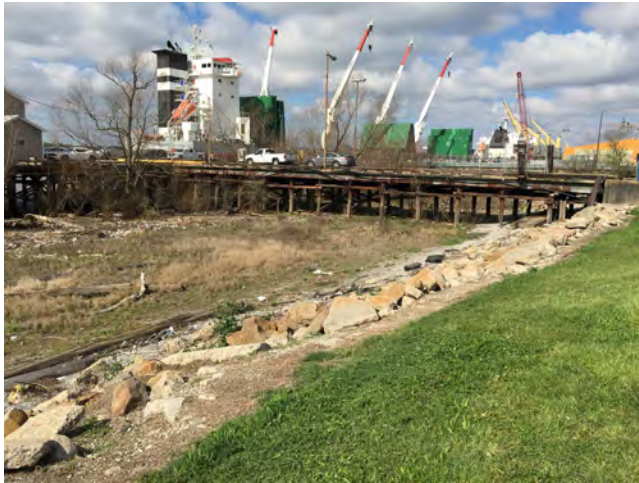
**Inspect ID:** USACE\_CEMVN\_OLD3\_2017\_a\_0006

**Inspection Remarks:** The slope paving is crumbling at the head of the wharf. This location has rip rap and sandbags placed from previous flood events but has begun to erode again. Sandbags have deteriorated.

**Recommended Action:** SLFPA-E should coordinate with wharf owner to make repairs under wharf and add temporary repair (rocks or sandbags) as needed.

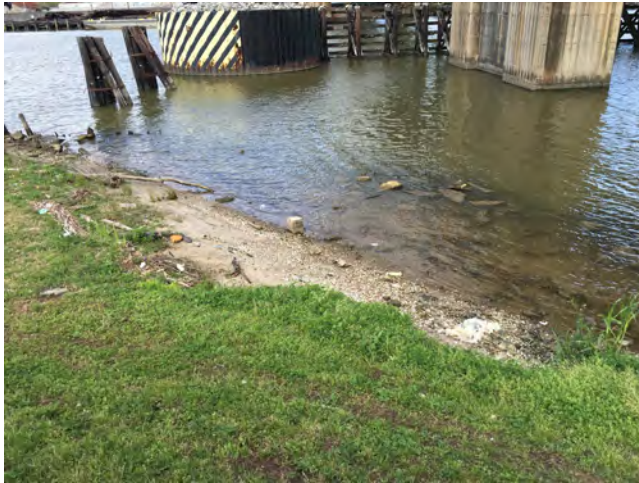
**Inspect ID:** USACE\_CEMVN\_OLD3\_2017\_a\_0003

USACE_CEMVN_OLD3_2017_a_0003: Station_1 10+95: Erosion of bankline near floodwall at Claiborne Ave. SLFPA-E should monitor the erosion and notify USACE if conditions worsen. (M)

**Rated Item:** 06. Foundation of Concrete Structures
