SUBJECT: 2016 Annual (Operations and Maintenance) Compliance Inspection for Orleans Levee District – New Orleans East Bank (Orleans Metro Subbasin) (OLD1)

Flood Damage Reduction Segment / System Inspection Report

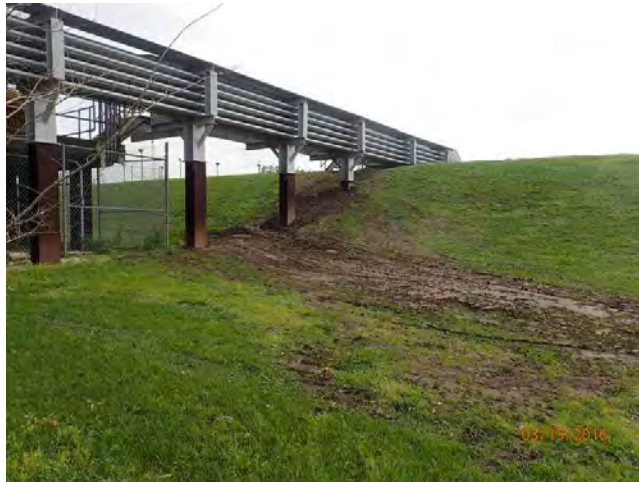
Inspect ID: USACE_CEMVN_OLD1_2016_a_0030

02. Sod Cover	M	A There is good coverage of sod over the levee.	USACE_CEMVN_OLD1_2016_a_0030: Station_1 13+62: Poor sod cover under a cat walk on the landside levee slope. OLD shall fertilize and seed areas until adequate sod cover is achieved. (M)
		M Approximately 25% of the sod cover is missing or damaged over a significant portion or over significant portions of the levee embankment. This may be the result of over-grazing or feeding on the levee, unauthorized vehicular traffic, chemical or insect problems, or burning during inappropriate seasons.	
		U Over 50% of the sod cover is missing or damaged over a significant portion or portions of the levee embankment.	
		N/A Surface protection is provided by other means.

Station 1: 13+62 (OCW)

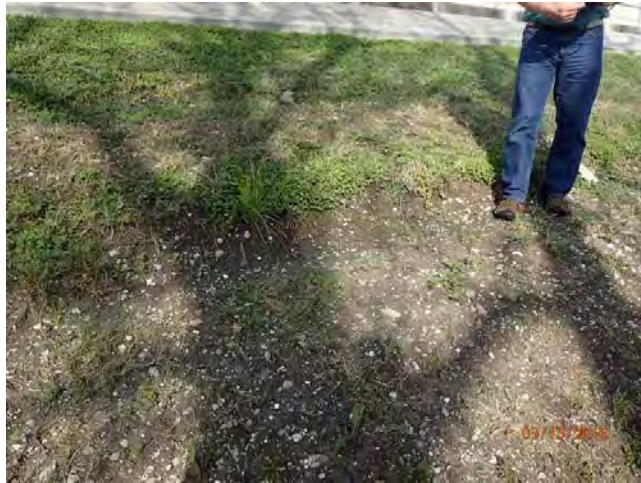
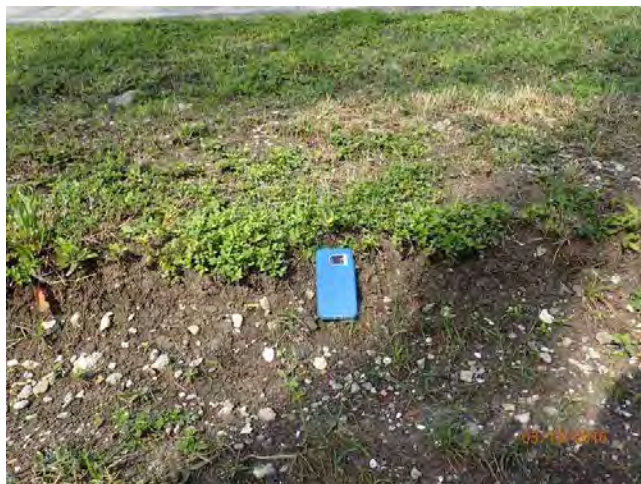
Inspect ID: USACE_CEMVN_OLD1_2016_a_0026

Station 1: 82+88 (LCE)

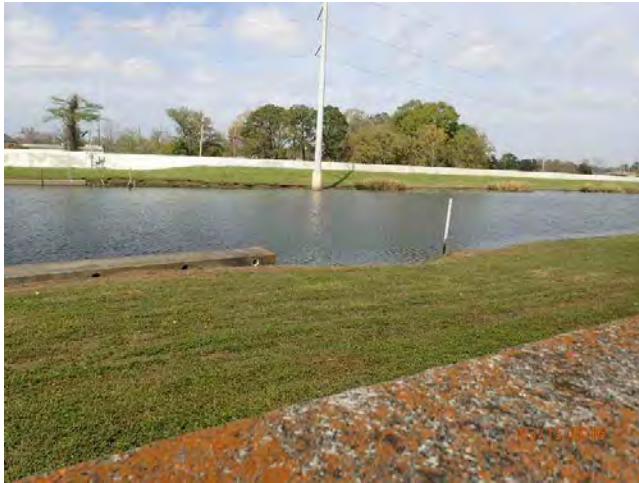
Inspect ID: USACE_CEMVN_OLD1_2016_a_0032

Station 1: 122+75 (17E)

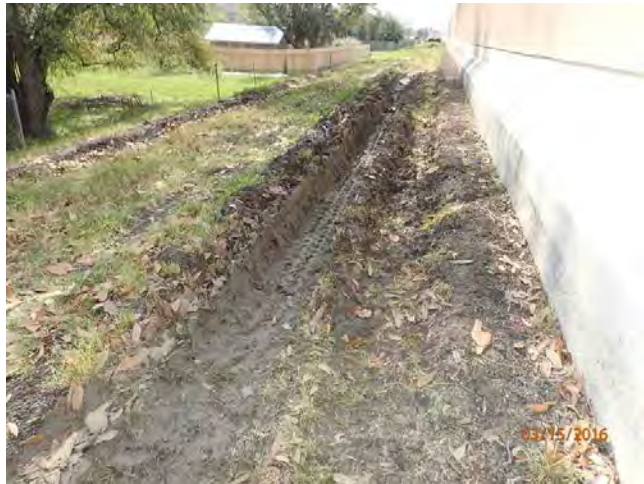
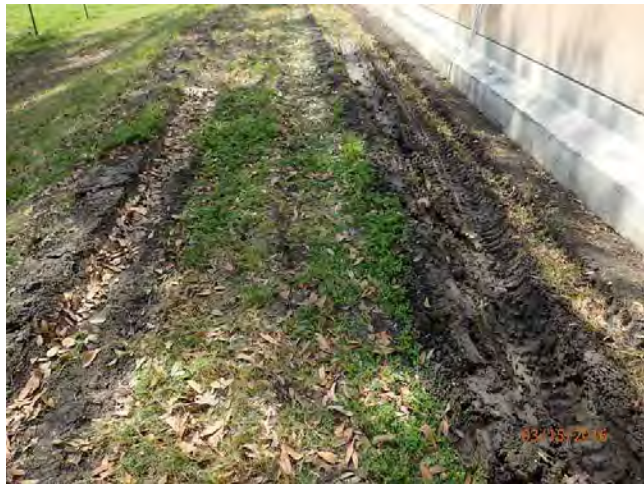
Inspect ID: USACE_CEMVN_OLD1_2016_a_0031

Station 1: 39+66 (17E)

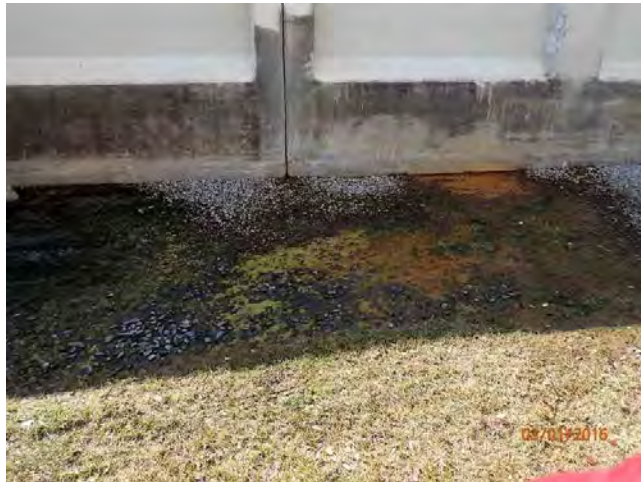
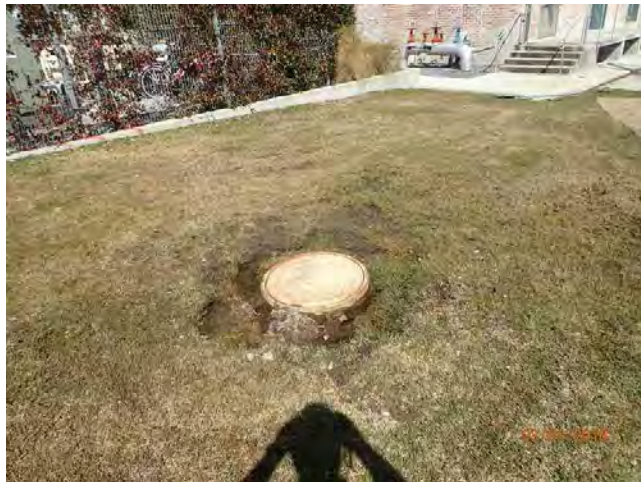
Inspect ID: USACE_CEMVN_OLD1_2016_a_0008

Inspection Remarks: Water main leak on the landside of the floodwall.

Station 1: 535+92 (OLD)

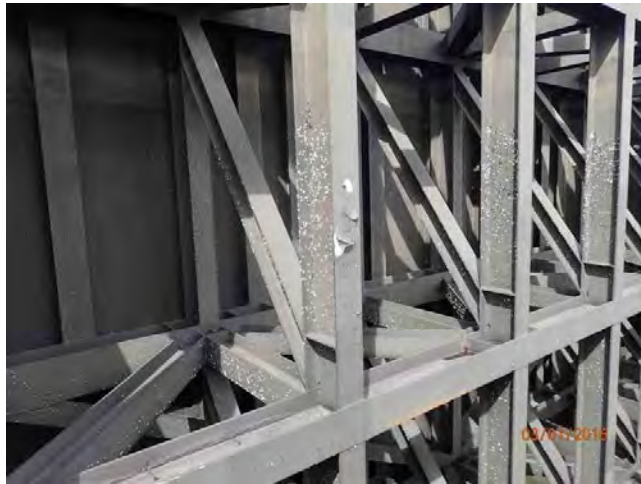
Inspect ID: USACE_CEMVN_OLD1_2016_a_0012

Station 1: 422+68 (OP)

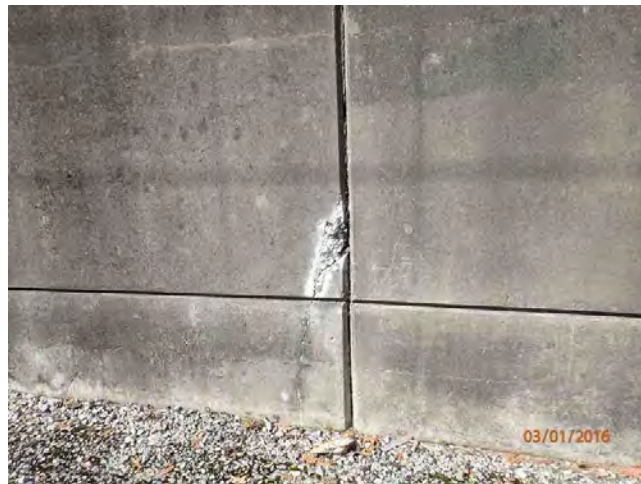
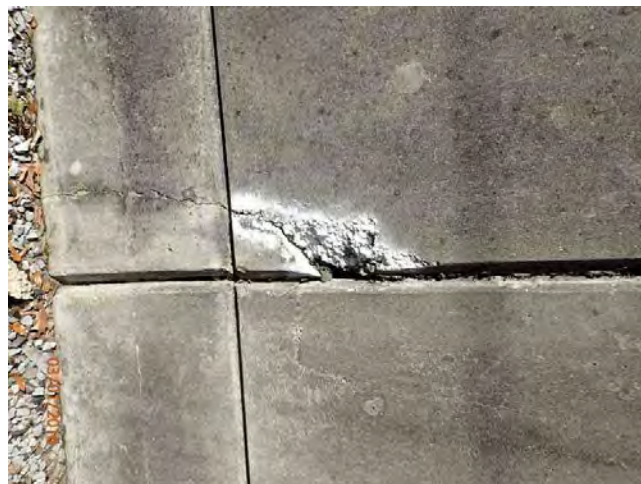
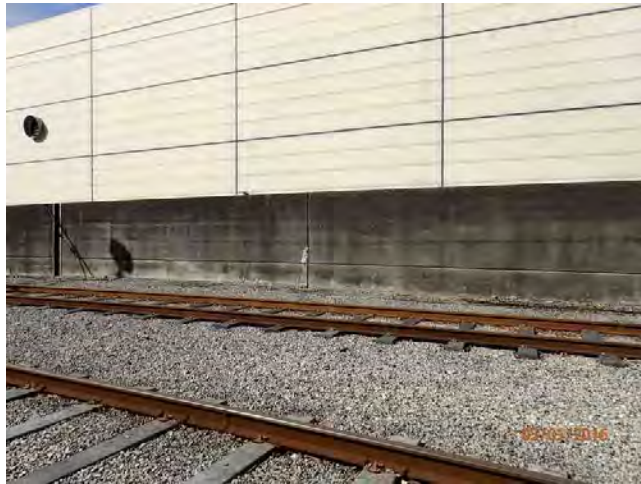
Inspect ID: USACE_CEMVN_OLD1_2016_a_0002

Station 1: 430+09 (OLD)

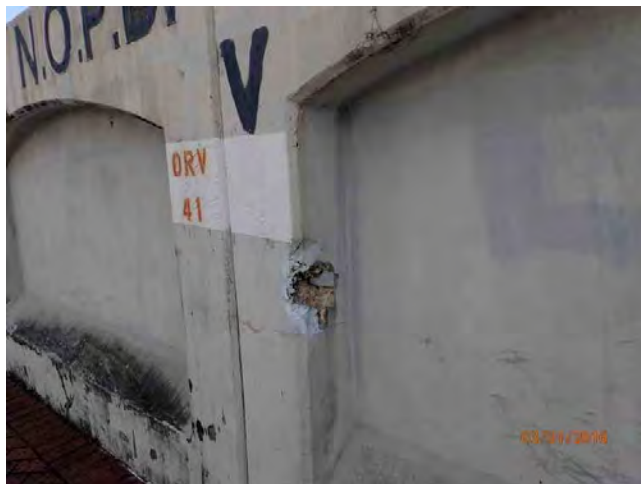
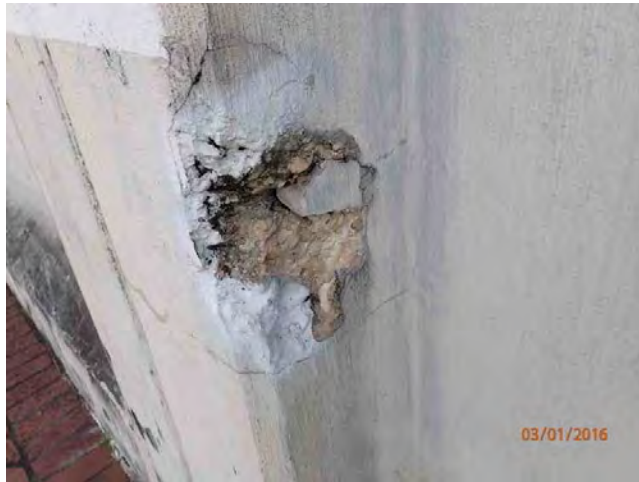
Inspect ID: USACE_CEMVN_OLD1_2016_a_0005

Station 1: 502+28 (OLD)

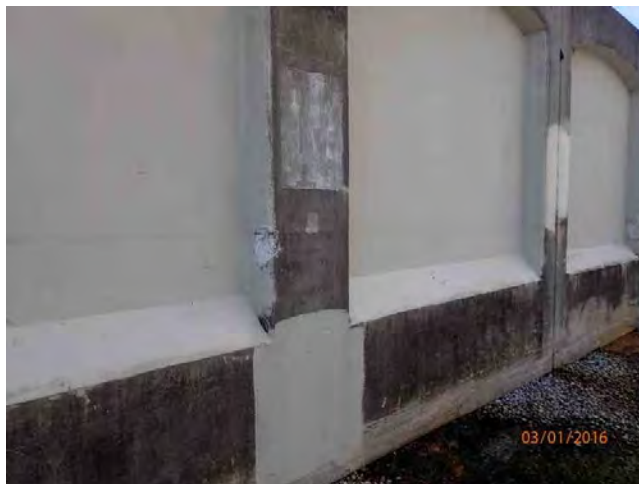
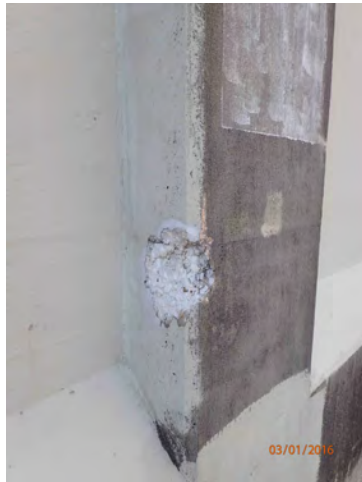
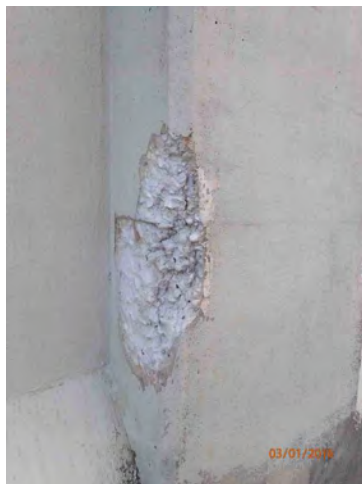
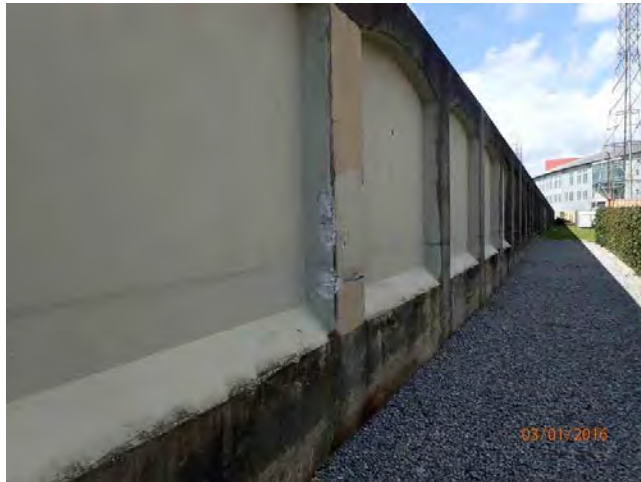
Inspect ID: USACE_CEMVN_OLD1_2016_a_0006

Station 1: 535+96 (OLD)

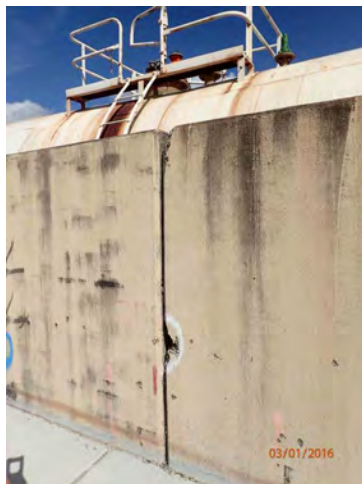
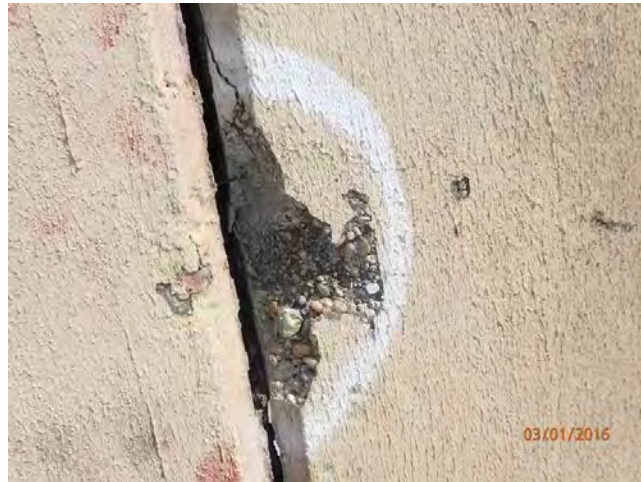
Inspect ID: USACE_CEMVN_OLD1_2016_a_0007

Station 1: 574+39 (OLD)

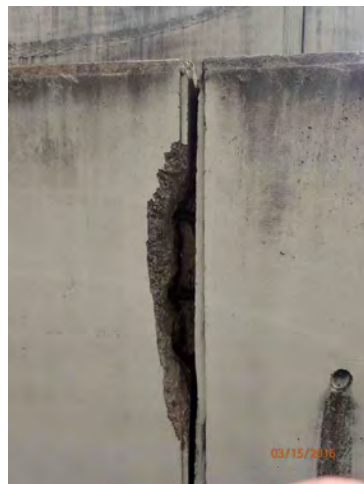
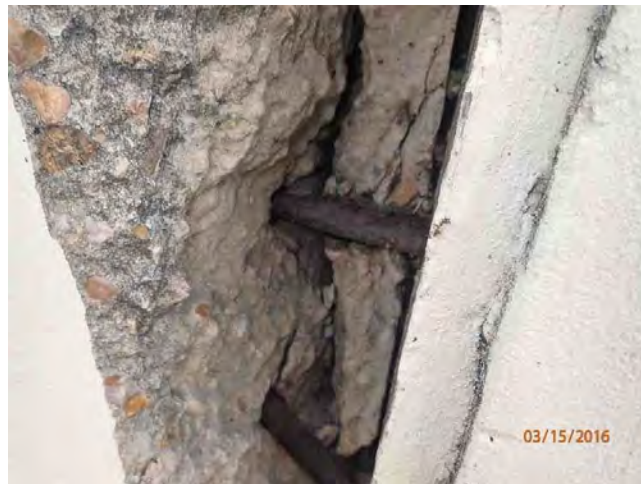
Inspect ID: USACE_CEMVN_OLD1_2016_a_0033

Station 2: 47+32 (OCW)

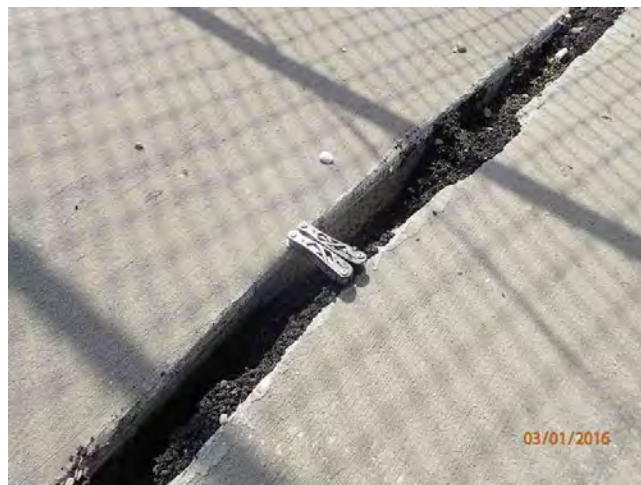
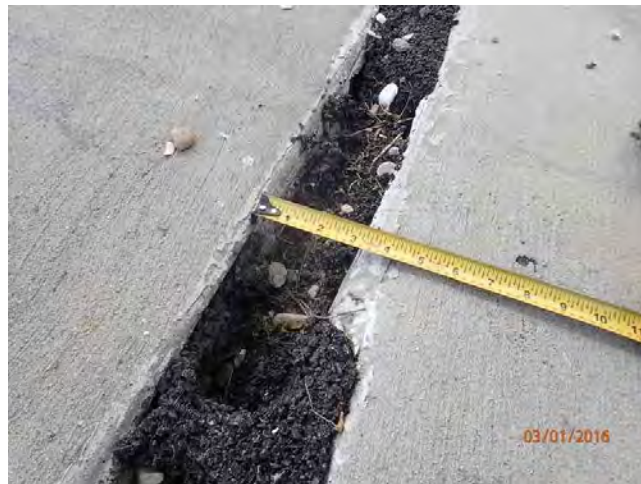
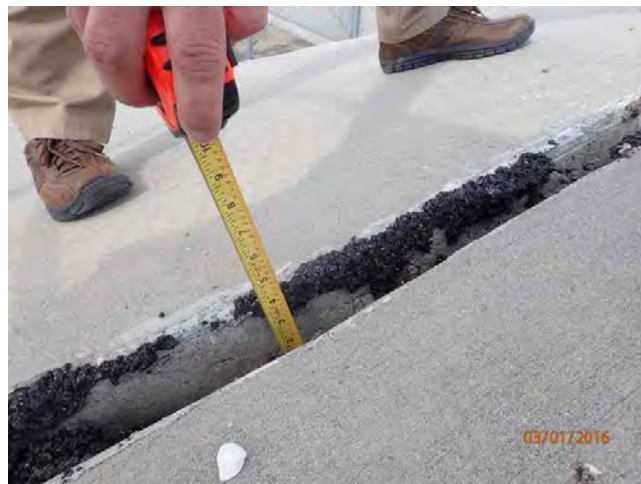
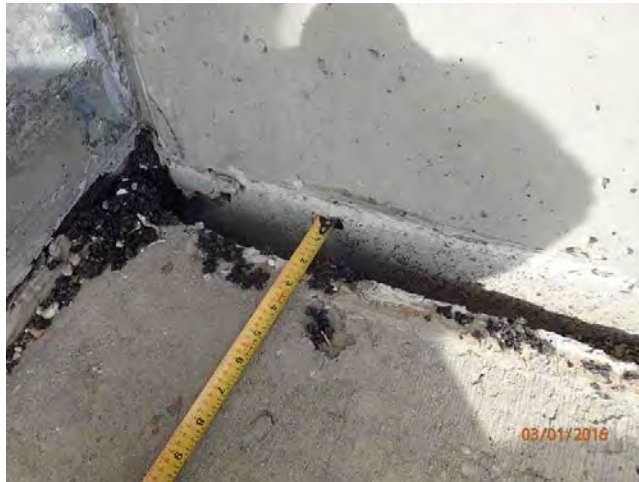
Inspect ID: USACE_CEMVN_OLD1_2016_a_0010

Station 1: 414+78 (OP)

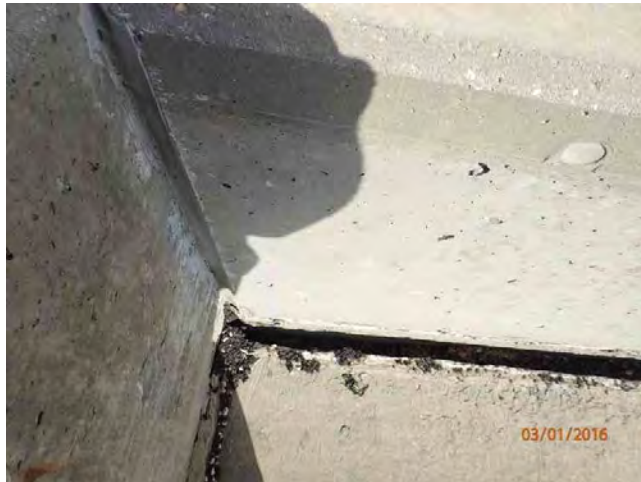
Inspect ID: USACE_CEMVN_OLD1_2016_a_0013
Title: USACE_CEMVN_OLD1_2016_a_0013_1.jpg
Rated Item: 06. Foundation of Concrete Structures
Rating: M
Inspection Remarks: Settlement and deterioration of the scour protection sealant.
Recommended Action: Old shall repair in accordance with Volume 2 OMRR&R Manual.
Caption:
Station 1: 422+33 (OP)

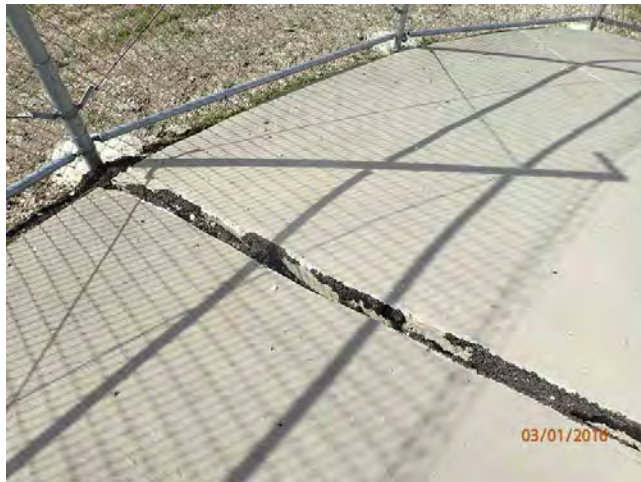
Inspect ID: USACE_CEMVN_OLD1_2016_a_0013
Title: USACE_CEMVN_OLD1_2016_a_0013_3.jpg
Rated Item: 06. Foundation of Concrete Structures
Rating: M
Inspection Remarks: Settlement and deterioration of the scour protection sealant.
Recommended Action: Old shall repair in accordance with Volume 2 OMRR&R Manual.
Caption:
Station 1: 422+33 (OP)
