SUBJECT: 2016 Annual (Operations and Maintenance) Compliance Inspection for Orleans Levee District – New Orleans East Bank (Orleans East Subbasin) (OLD2)

Flood Damage Reduction Segment / System Inspection Report

Orleans LD - New Orleans East Bank (Orleans East Subbasin) 2016 routine inspection (OLD2_2016_a)

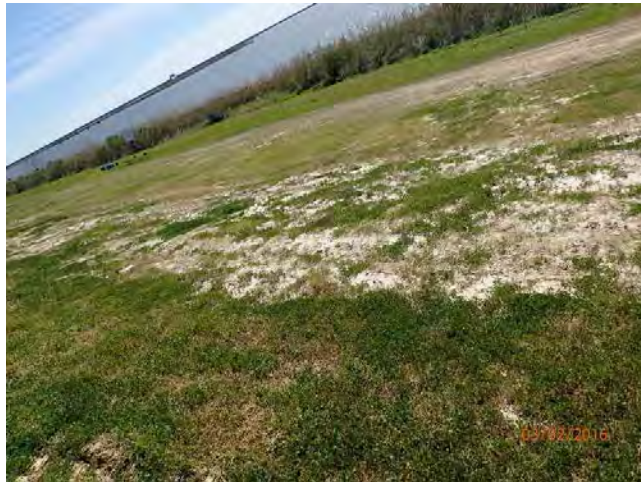
Inspect ID: USACE_CEMVN_OLD2_2016_a_0008

02. Sod Cover	M	A There is good coverage of sod over the levee.	USACE_CEMVN_OLD2_2016_a_0008: Station_1 338+04: Poor sod cover on floodside slope. OLD should fertilize and seed areas until adequate sod cover is achieved. (M) USACE_CEMVN_OLD2_2016_a_0013: Station_1 1063+27: Poor sod cover with shells washing out along slope. No picture. OLD should fertilize and seed areas until adequate sod cover is achieved. (M)
		M Approximately 25% of the sod cover is missing or damaged over a significant portion or over significant portions of the levee embankment. This may be the result of over-grazing or feeding on the levee, unauthorized vehicular traffic, chemical or insect problems, or burning during inappropriate seasons.	
		U Over 50% of the sod cover is missing or damaged over a significant portion or portions of the levee embankment.	
		N/A Surface protection is provided by other means.

Recommended Action: OLD should fertilize and seed areas until adequate sod cover is achieved.

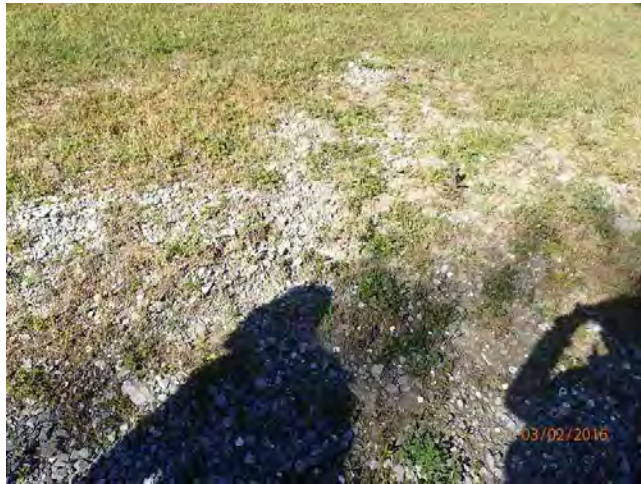
Inspect ID: USACE_CEMVN_OLD2_2016_a_0001

06. Erosion/ Bank Caving	M	A	<p>USACE_CEMVN_OLD2_2016_a_0001: Station_1 39+05: Station_2 50+82: Erosion on landside slope. USACE Project Management is coordinating with OLD to repair erosion in this area. (M)</p> <p>USACE_CEMVN_OLD2_2016_a_0007: Station_1 81+72: Floodside bank erosion near pipeline. Rocks and bank eroded. At current time erosion does not affect floodwall stability. OLD should monitor erosion. (A)</p> <p>USACE_CEMVN_OLD2_2016_a_0009: Station_1 395+88: Erosion on land side slope. OLD should repair eroded areas with compacted clay fill. The areas should then be fertilized and seeded. (M)</p> <p>USACE_CEMVN_OLD2_2016_a_0010: Station_1 394+49: Erosion on land side slope. OLD should repair eroded areas with compacted clay fill. The areas should then be fertilized and seeded. (M)</p>	
		M		There are areas where minor erosion is occurring or has occurred on or near the levee embankment, but levee integrity is not threatened.

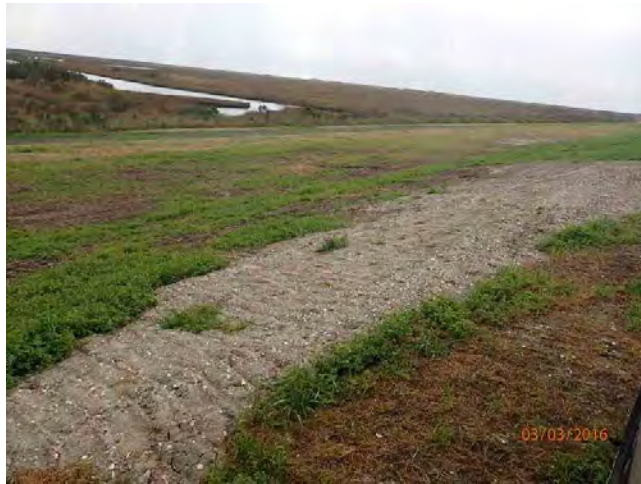
Inspect ID: USACE_CEMVN_OLD2_2016_a_0014
Title: USACE_CEMVN_OLD2_2016_a_0014_1.jpg
Rated Item: 10. Animal Control
Rating: A
Inspection Remarks: Hog damage repair.
Recommended Action: OLD is actively repairing damage.
Caption:
Station 1: 1042+70 (NOE)

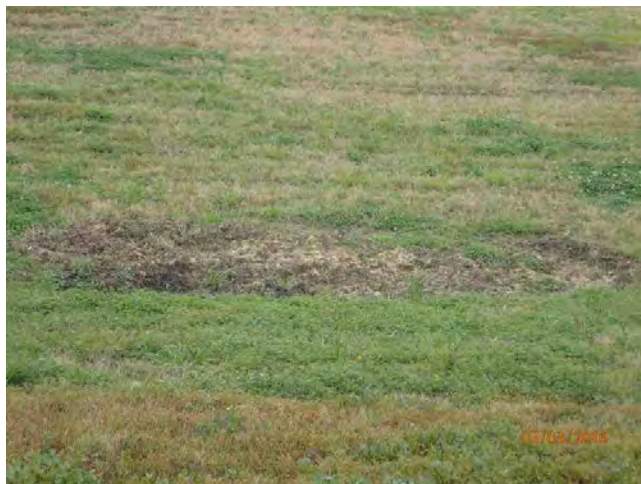
Inspect ID: USACE_CEMVN_OLD2_2016_a_0017
Title: USACE_CEMVN_OLD2_2016_a_0017_1.jpg
Rated Item: 10. Animal Control
Rating: M
Inspection Remarks: Hog damage throughout reach.
Recommended Action: OLD should inspect and repair damaged areas with compacted clay fill. The areas should then be fertilized and seeded.
Caption:
Station 1: 733+99 (NOE)
Station 2: 755+15 (NOE)
