SUBJECT: 2017 Annual (Operations and Maintenance) Compliance Inspection for Lake Borgne Basin Levee District – New Orleans East Bank (LBL1)

Flood Damage Reduction Segment / System Inspection Report

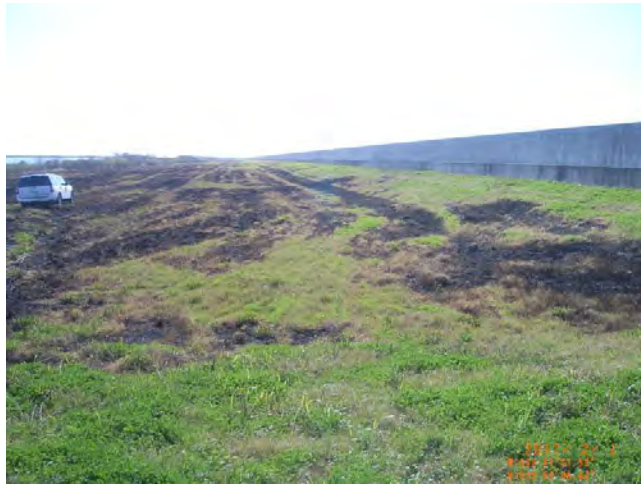
Inspect ID: USACE_CEMVN_LBL1_2017_a_0067

Inspection Remarks: Untravelable condition on floodside levee from Bayou Bievenue to Bayou Dupre due to ground saturated.

Recommended Action: Last year points from Bayou Bievenue to Bayou Dupre could not be verify due to these condition.

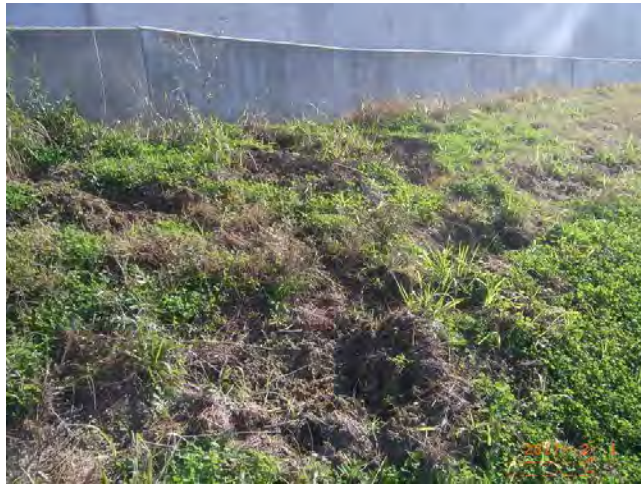
Inspect ID: USACE_CEMVN_LBL1_2017_a_0062

Inspection Remarks: Hog damage on landside levee slope and toe.

Recommended Action: SLFPA-E should inspect and repair burrows or damaged areas with compacted clay fill. The areas should then be fertilized and seeded.

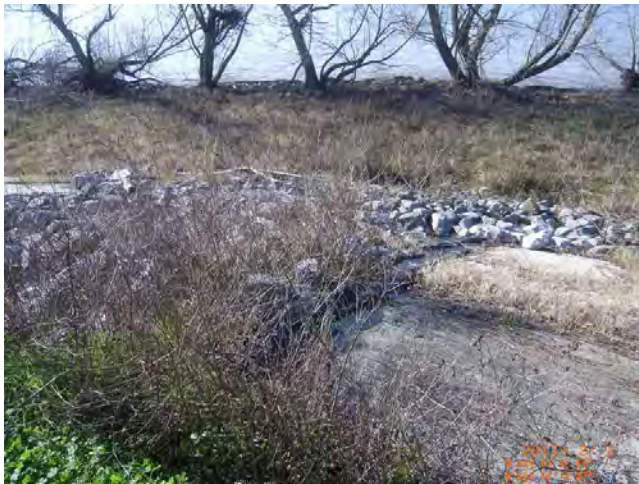
Inspect ID: USACE_CEMVN_LBL1_2017_a_0031

Inspection Remarks: Temporary riprap repair of slope pavement.

Recommended Action: SLFPA-E will provide permanent repairs.

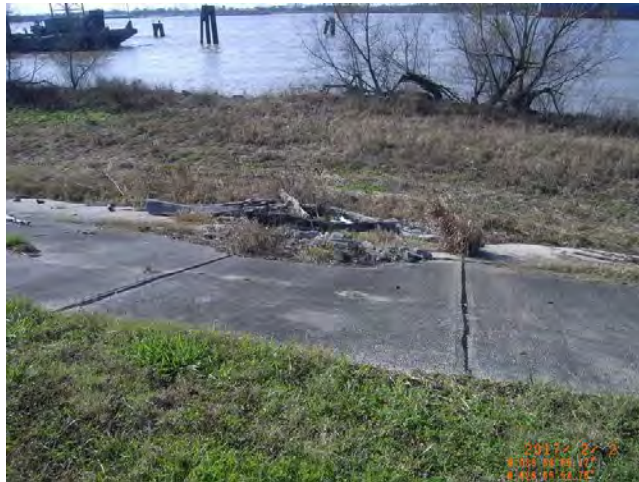
Inspect ID: USACE_CEMVN_LBL1_2017_a_0037

Inspection Remarks: Temporary riprap repair on floodside slope pavement.

Recommended Action: SLFPA-E will provide permanent repairs.

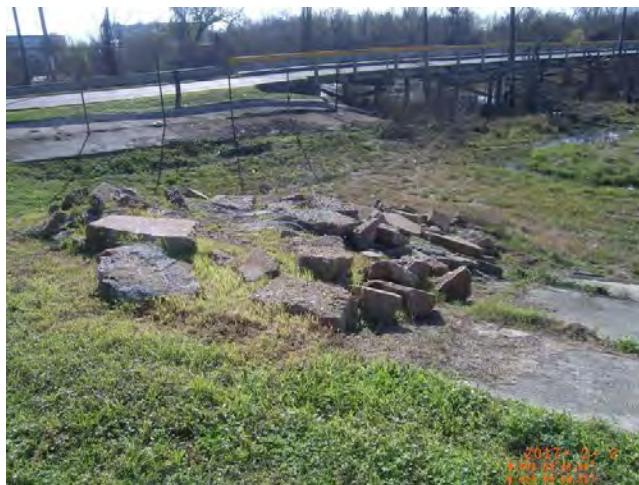
Inspect ID: USACE_CEMVN_LBL1_2017_a_0040

Inspection Remarks: Temporary riprap repair on floodside slope pavement.

Recommended Action: SLFPA-E will provide permanent repairs.

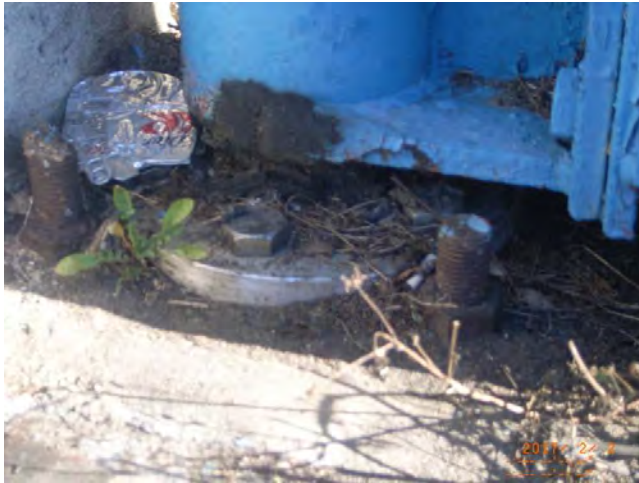
Inspect ID: USACE_CEMVN_LBL1_2017_a_0017

Inspection Remarks: Bolts thread in concrete on floodgate are corroded.
