US Army Corps of Engineers

Flood Damage Reduction Segment / System Inspection Report

Name of Segment / System : Orleans LD - New Orleans East Bank (Orleans Metro Subbasin) (OLD1)
 Public Sponsor(s): Southeast Louisiana Flood Protection Authority - East
 Public Sponsor Representative: Robert Turner - Regional Director
 Sponsor Phone: 504 262-8902
 Sponsor Email: rturner@slfpa.com
 Corps of Engineers Inspector: Kelly Danton, Carl Balint, David Duthu, Nicholas Ferina, Paul Wiltz, Raehael Maltzahn, Jabeen Pasha, Ben S Barcelona
 Inspection Report Prepared By: Nicholas Ferina, David Duthu
 Internal Technical Review (For Periodic Inspection): Prepared By: Mark Woodward, P.E.
 Final Approved By: Jean Vossen, P.E. *JV* Date of ITR: *13/17*
 Inspection Start Date: 03/16/2017
 Inspection End Date: 04/12/2017
 Date Report Prepared: 04/17/2017
 Date Approved: *10/4/17*

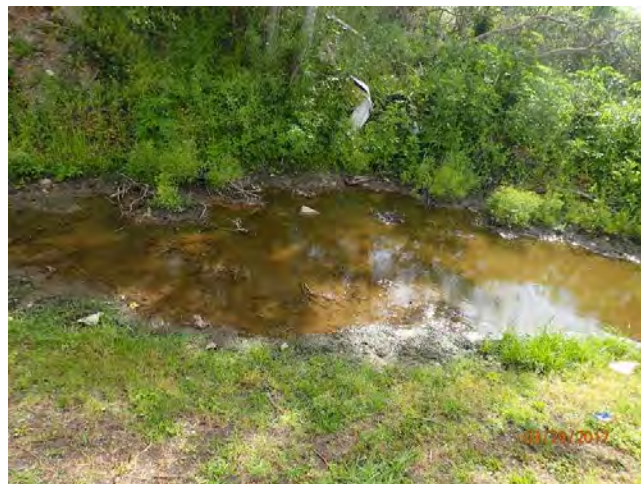
Inspect ID: USACE_CEMVN_OLD1_2017_a_0107

Station 1: 15+33 (OCE)

Recommended Action: SLFPA-E shall ensure proper drainage. SLFPA-E shall repair depressed or rutted areas with compacted clay fill. The areas shall then be fertilized and seeded.

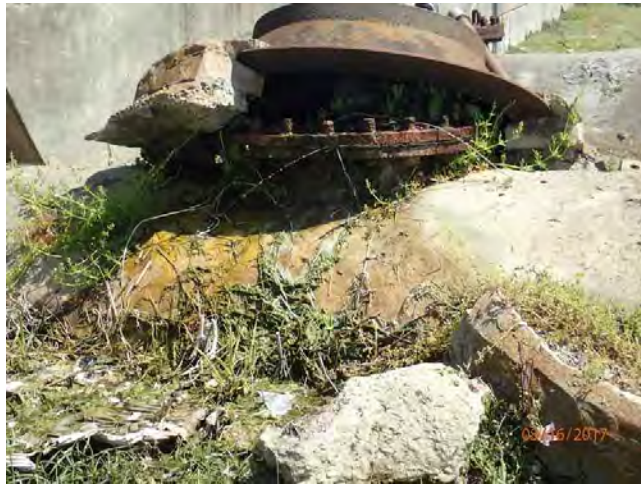
Inspect ID: USACE_CEMVN_OLD1_2017_a_0011

Inspection Remarks: Leaking water pipe on the floodside.

Recommended Action: SLFPA-E should coordinate with the Sewerage and Water Board to make corrective action.

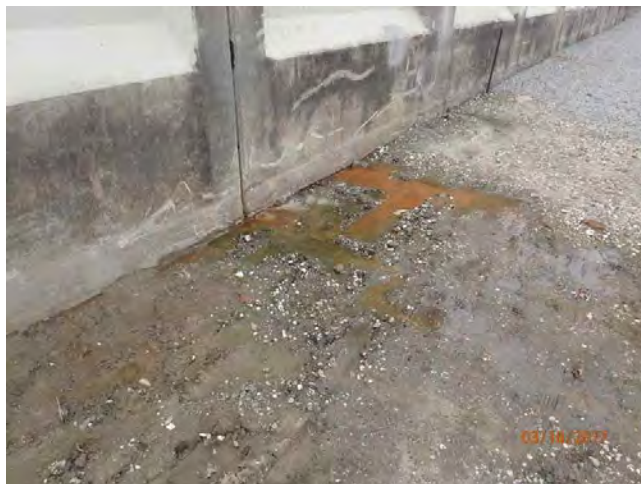
Inspect ID: USACE_CEMVN_OLD1_2017_a_0024

Inspection Remarks: Leaking fire hydrant causing ponding water at the base of floodwall.

Recommended Action: SLFPA-E should coordinate with the Sewerage and Water Board to make corrective action.

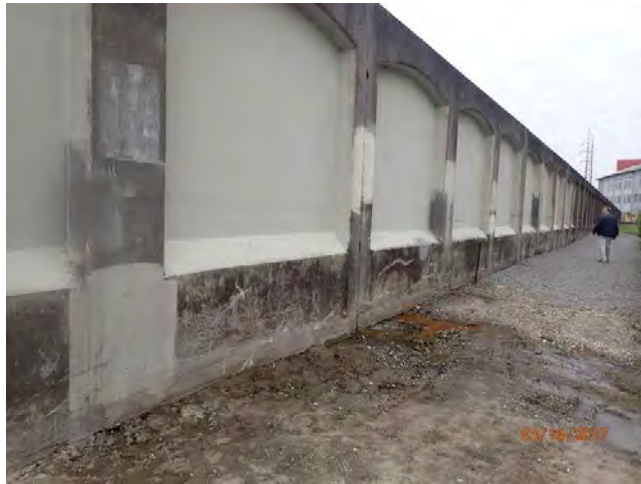
Inspect ID: USACE_CEMVN_OLD1_2017_a_0024

Inspection Remarks: Leaking fire hydrant causing ponding water at the base of floodwall.

Recommended Action: SLFPA-E should coordinate with the Sewerage and Water Board to make corrective action.

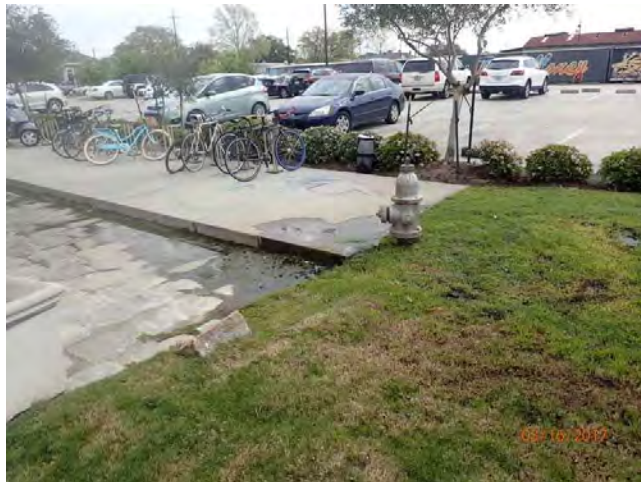
Inspect ID: USACE_CEMVN_OLD1_2017_a_0024

Inspection Remarks: Leaking fire hydrant causing ponding water at the base of floodwall.

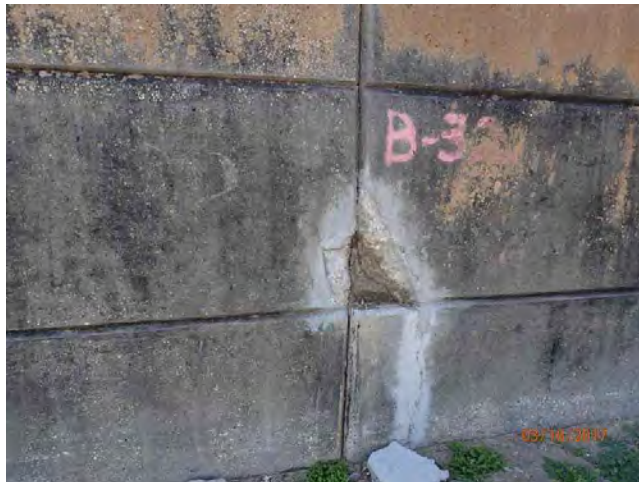
Inspect ID: USACE_CEMVN_OLD1_2017_a_0019

04. Concrete Surfaces	M	A	<p>Negligible spalling, scaling or cracking. If the concrete surface is weathered or holds moisture, it is still satisfactory but should be seal coated to prevent freeze/ thaw damage.</p> <p>USACE_CEMVN_OLD1_2017_a_0001: Station_1 430+09: Spalling/cracking of the flood side of floodwall. SLFPA-E shall make corrective actions as required. (M)</p>
		M	<p>Spalling, scaling, and open cracking present, but the immediate integrity or performance of the structure is not threatened. Reinforcing steel may be exposed. Repairs/ sealing is necessary to prevent additional damage during periods of thawing and freezing.</p> <p>USACE_CEMVN_OLD1_2017_a_0012: Station_1 189+78: Spalling at top of wall. SLFPA-E shall monitor concrete cracking/degradation and make corrective actions as required. (M)</p>
		U	<p>Surface deterioration or deep cracks present that may result in an unreliable structure. Any surface deterioration that exposes the sheet piling or lies adjacent to monolith joints may indicate underlying reinforcement corrosion and is unacceptable.</p> <p>USACE_CEMVN_OLD1_2017_a_0013: Station_1 234+91: Spall along joint of floodwall. SLFPA-E shall monitor concrete cracking/degradation and make corrective actions as required. (M)</p> <p>USACE_CEMVN_OLD1_2017_a_0014: Station_1 251+76: Spall along joint of floodwall. SLFPA-E shall monitor concrete cracking/degradation and make corrective actions as required. (M)</p> <p>USACE_CEMVN_OLD1_2017_a_0016: Station_1 263+13: Spall along joint of floodwall. SLFPA-E shall monitor concrete cracking/degradation and make corrective actions as required. (M)</p> <p>USACE_CEMVN_OLD1_2017_a_0017: Station_1 247+84: Previously repaired spall but deteriorating again. SLFPA-E shall monitor concrete cracking/degradation and make corrective actions as required. (M)</p> <p>USACE_CEMVN_OLD1_2017_a_0019: Station_1 263+32: Previously repaired spall but deteriorating again.</p>

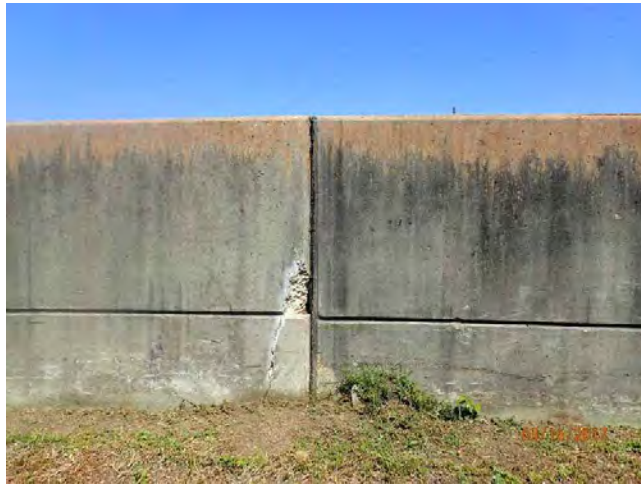
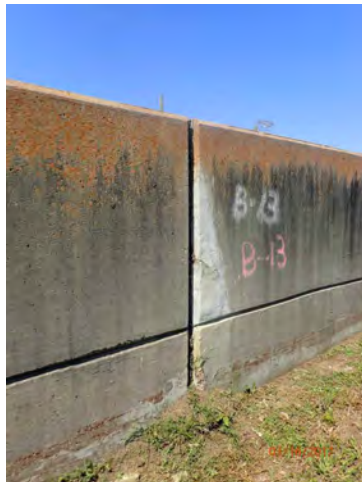
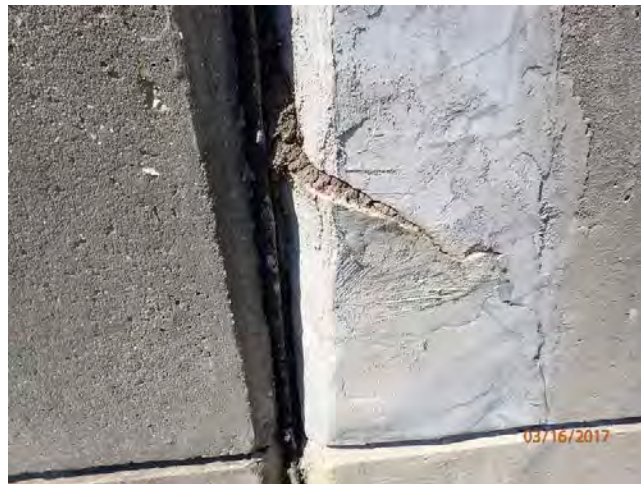
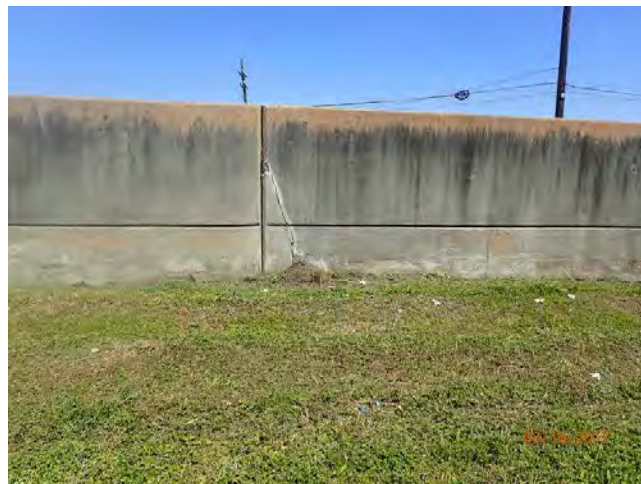
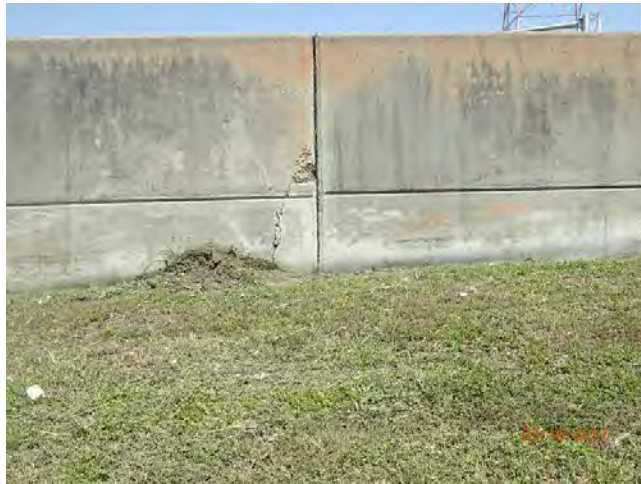
Inspect ID: USACE_CEMVN_OLD1_2017_a_0022

Rated Item	Rating	Rating Guidelines	Locations/Remarks/Recommendations
			<p>SLFPA-E shall monitor concrete cracking/degradation and make corrective actions as required. (M)</p> <p>USACE_CEMVN_OLD1_2017_a_0022: Station_1 67+13: Station_2 74+47: Numerous spalls along the landside of the floodwall. SLFPA-E shall monitor concrete cracking/degradation and make corrective actions as required. (M)</p> <p>USACE_CEMVN_OLD1_2017_a_0025: Station_1 533+90: Spalling/cracking of the land side of floodwall. SLFPA-E shall make corrective actions as required. (M)</p> <p>USACE_CEMVN_OLD1_2017_a_0103: Station_1 77+28: Station_2 84+06: Exposed rebar on the landside retaining wall below the floodwall at Orleans Canal. SLFPA-E shall make corrective actions as required. (M)</p>

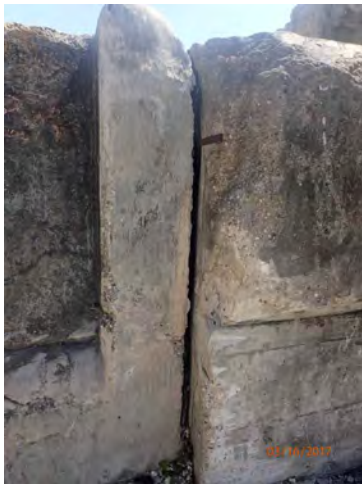
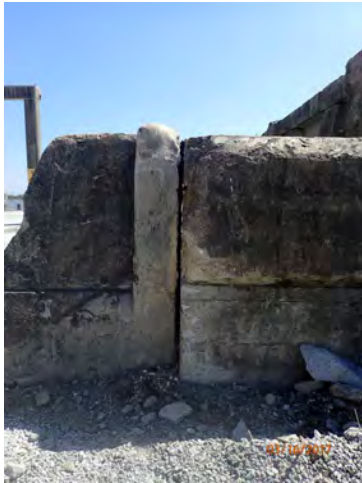
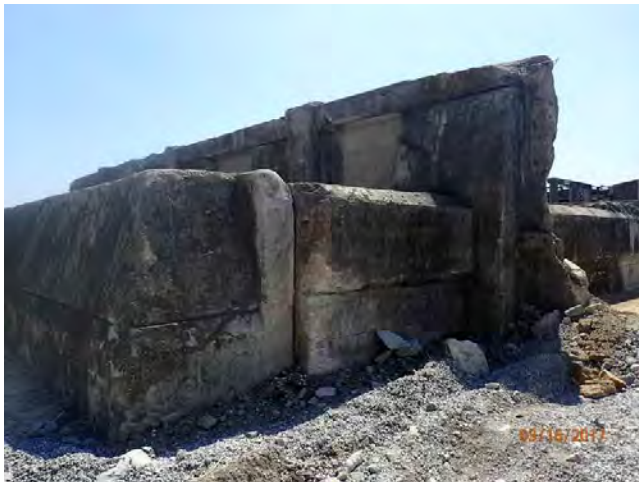
Inspect ID: USACE_CEMVN_OLD1_2017_a_0006

07. Monolith Joints	M	A The joint material is in good condition. The exterior joint sealant is intact and cracking/desiccation is minimal. Joint filler material and/or waterstop is not visible at any point.	USACE_CEMVN_OLD1_2017_a_0006: Station_1 53+25: Water stop deterioration. SLFPA-E needs to repair the expansion material between monolith joints. (M)
		M The joint material has appreciable deterioration to the point where joint filler material and/or waterstop is visible in some locations. This needs to be repaired or replaced to prevent spalling and cracking during freeze/ thaw cycles, and to ensure water tightness of the joint.	
		U The joint material is severely deteriorated or the concrete adjacent to the monolith joints has spalled and cracked, damaging the waterstop; in either case damage has occurred to the point where it is apparent that the joint is no longer watertight and will not provide the intended level of protection during a flood.
